A Multi-Program Approach to Identifying and Correcting Anthropogenic Bacteria Sources

Rhode Island DEM, Office of Water Resources
Surface Water Assessments

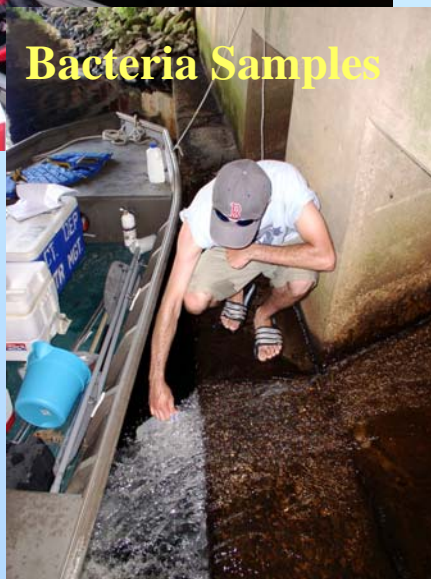
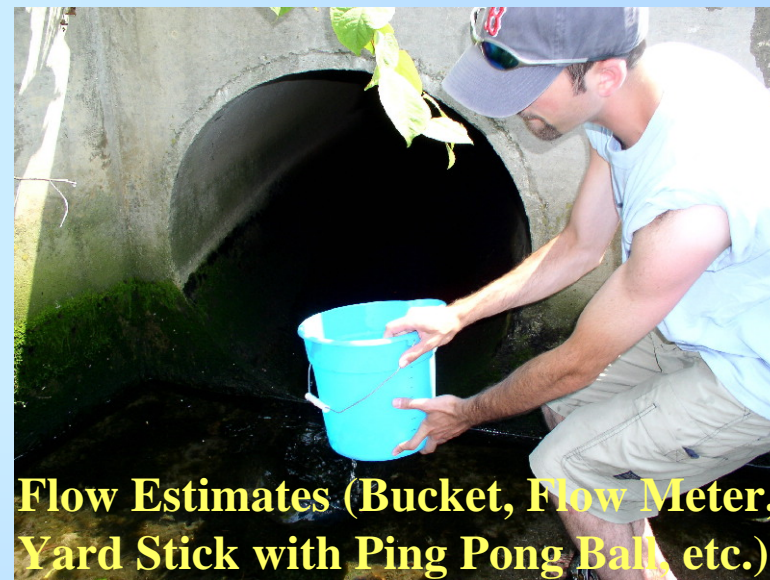
Bacteria Samples

Flow Estimates (Bucket, Flow Meter, Yard Stick with Ping Pong Ball, etc.)

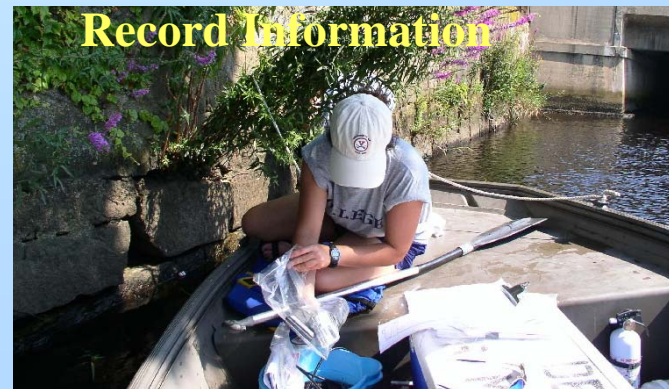
Record Information

Pawcatuck River Shoreline Survey RI Area # 1 RR Bridge to Margin St Date: 8/1/06 RI Team # 1

Source ID	Latitude 41° (Dec. Min.)	Longitude 71° (Dec. Min.)	Description and Location	Actual / Potential	Direct / Indirect	Flow (<u> </u> per sec.)	Source Dimensions (Width or Dia. X Stage)	Time	Results
2006-12-1-RI100	22.198'	49.908'	Storm Drain Picture: 4715	A	D	See notes	48" C Pipe	9:05	1600/ 410
2006-12-1-RI101	22.373'	49.896'	Storm Drain Picture: 4718-4719	A	D	See notes	36" C Pipe (right) ^{South}	9:28	71600/ 480
2006-12-1-RI102	22.373'	49.896'	Storm Drain Picture: 4718-4719	A	D	See notes	36" C Pipe (left) ^{North}	9:30	71600/ 347
2006-12-1-RI103	22.659'	49.881'	Storm Drain under Bridge Picture: 4732-4733	A	D	See notes	30" box outfall	10:07	1600/ 30
2006-12-1-RI114	22.310'	49.898'	Box Shaped outfall Picture: 4716	P	D	—	18" CMP	9:19	Grouped together
2006-12-1-RI115	22.354'	49.908'	Several outfalls Picture: 4717	P	D	—	18" CMP	9:19	
2006-12-1-RI116	22.354'	"	"	"	"	—	24" C	9:19	
2006-12-1-RI117	"	"	"	"	"	—	24" C	9:19

2006-12-1-RI118	"	"	"	"	"	—	18" C	9:19	
2006-12-1-RI119	22.395'	49.914'	Storm Drain Picture: 4720	"	"	—	24" C	9:44 9:44

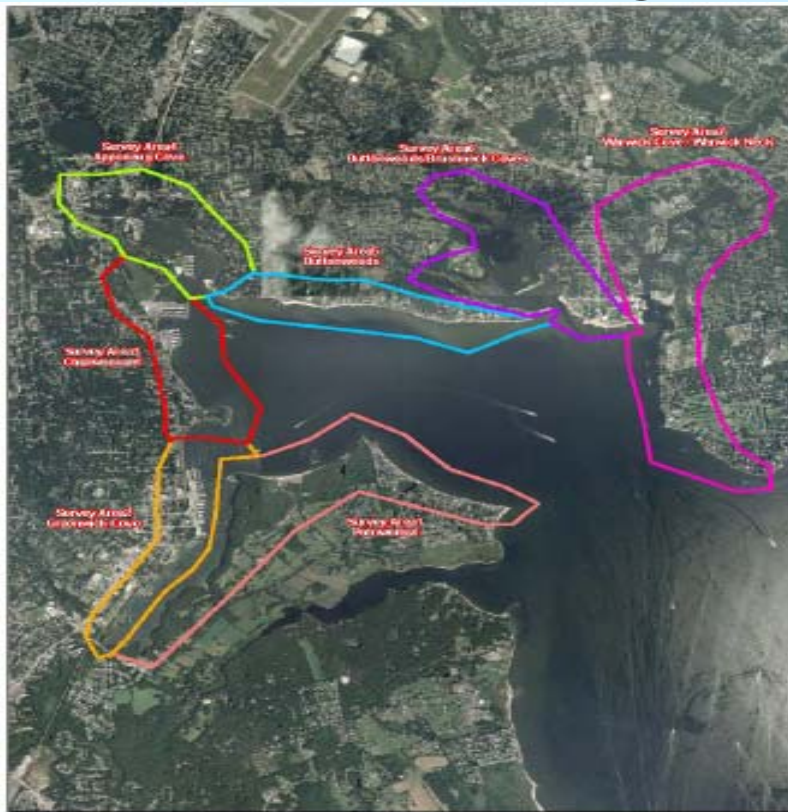
2005 Multi-Agency Shoreline Survey

- FDA NSSP requires RI to conduct a sanitary survey every twelve years.
- Shoreline Survey
 - Walk or Boat entire Shoreline.
 - Six Teams
 - Two Days
 - 27 Miles of Shoreline

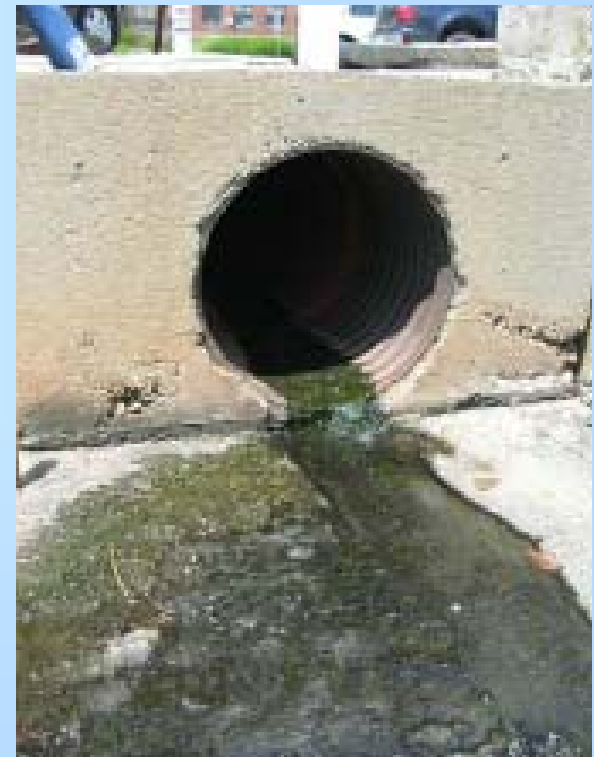
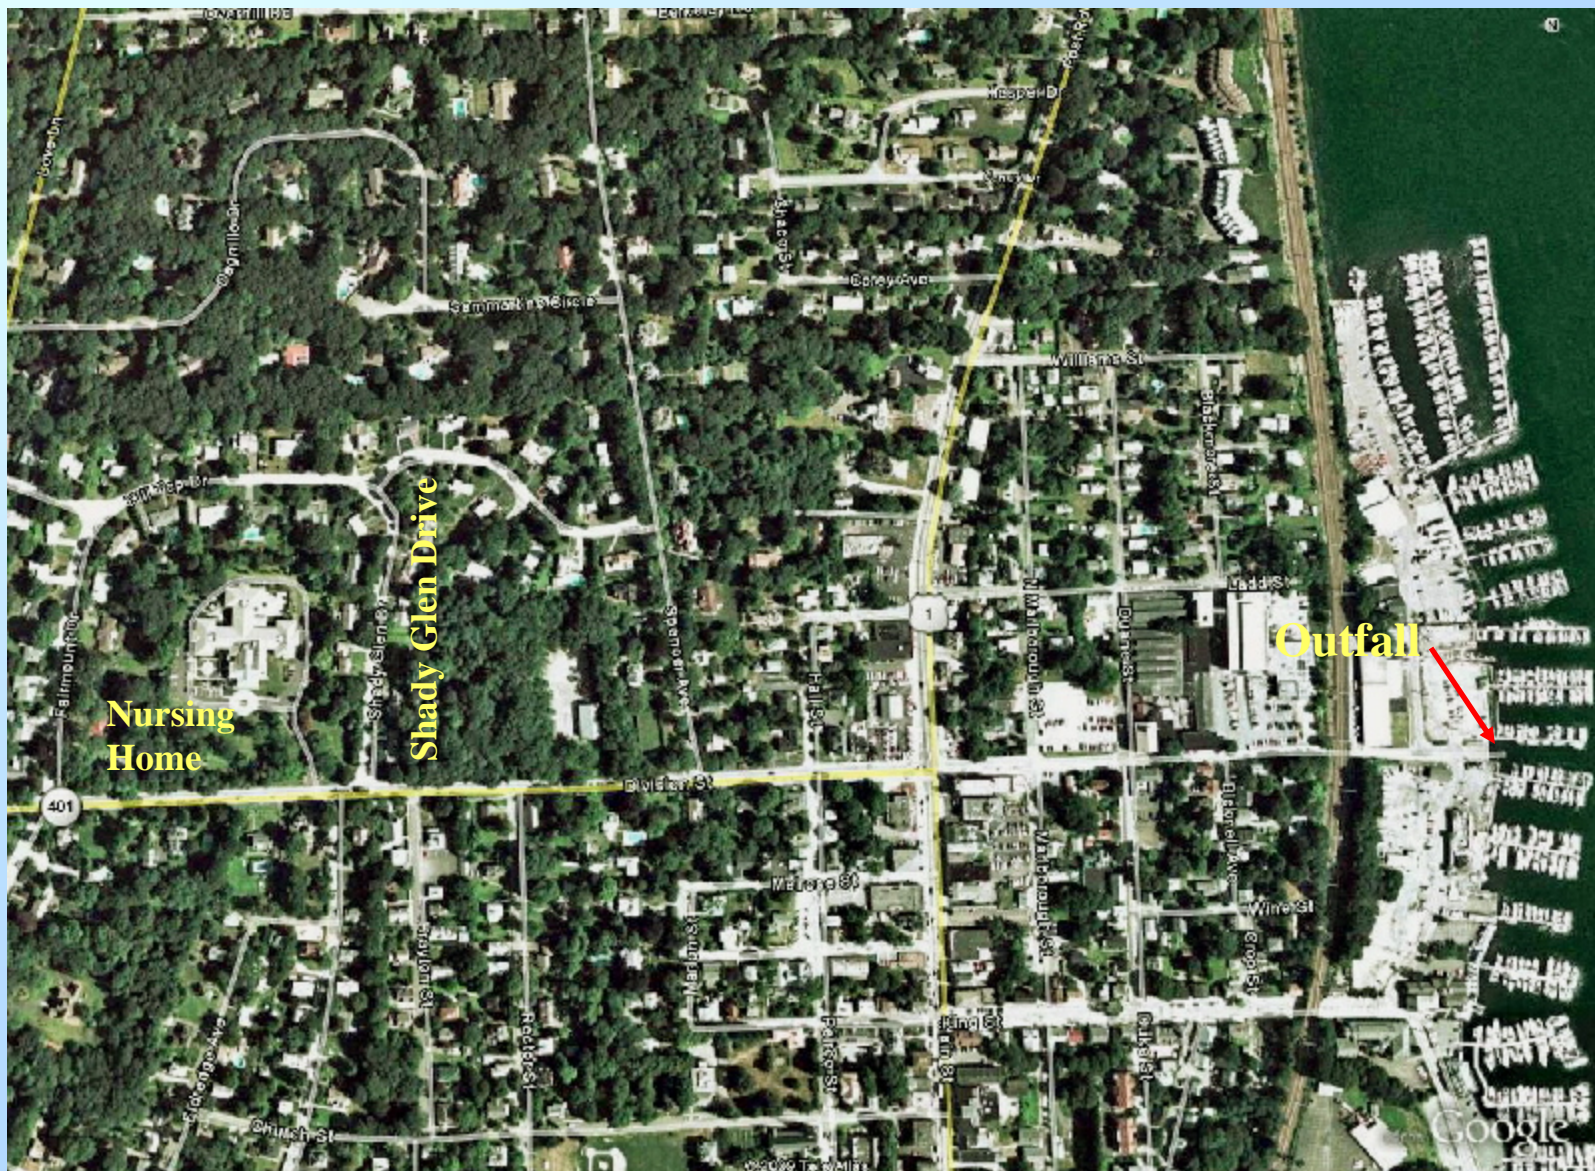
Division Street

- May 2005 Results
 - Fecal coliform ranged from 103 to 3800 fc/100ml.
 - Bacteria phage ranged from **70** to **520** pfu/100ml.
- OCI Investigation
 - Outfall owned by DOT, but areas of East Greenwich and Warwick drain into the outfall.

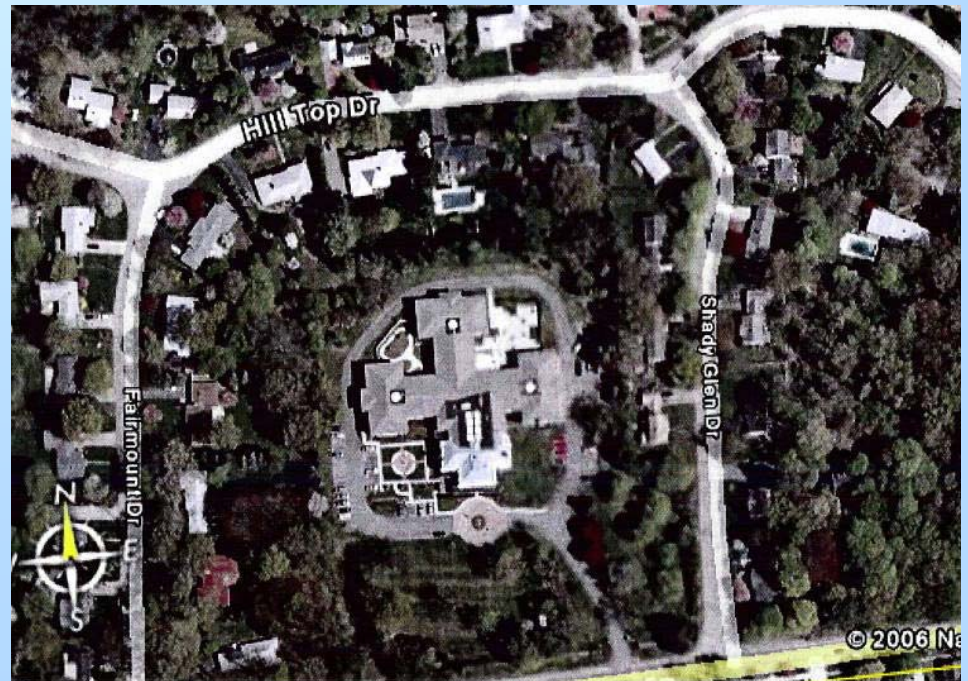
Outcome of OCI Investigations

- Neighborhoods using under drains that discharge to the storm drain.
- Nursing Home
- Shady Glen Drive
 - Dye Tests

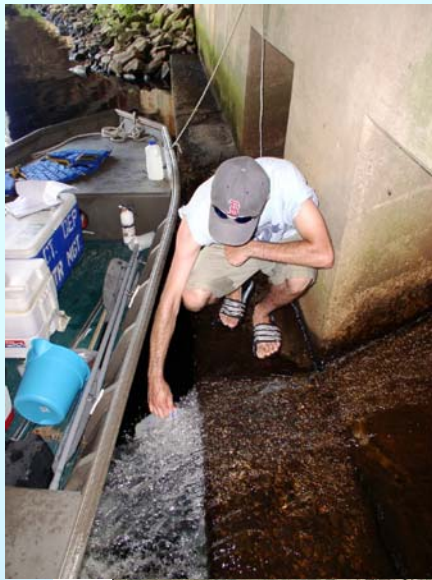
Pawcatuck River 2006 Multi-Agency Bacteria Study

- Sixteen instream stations sampled.
- Fifty-six potential bacteria sources identified with eleven sampled.
- Westerly WWTF, Pawcatuck WWTF, and freshwater Pawcatuck River sampled over several days.
- Shellfish meats sampled from four locations.

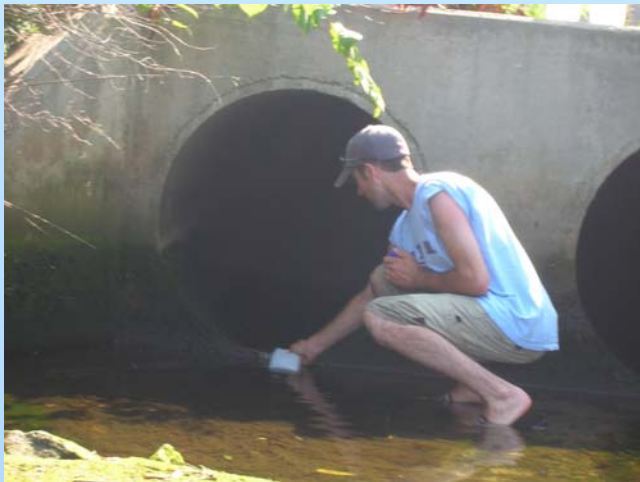
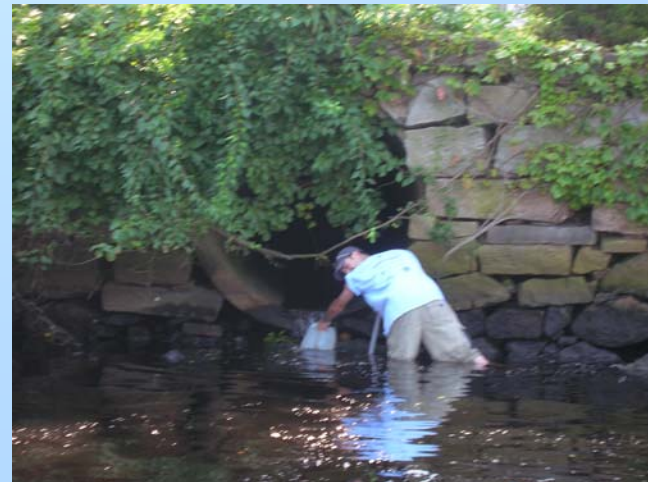
School St., Westerly, Storm Drain Sampling Locations & Results

Source ID	Description	8/1/2006			8/3/2006		
		Est. Discharge (L/Sec)	Fecal Colifom	Phage	Est. Discharge (L/Sec)	Fecal Colifom	Phage
RI100	48" C Pipe	1.72	1600	<10	1.52	9200	10
RI101	36" C Pipe (South-Right)	4.08	>1600	480	0.71	5400	310
RI102	36" C Pipe (North-Left)	1.64	>1600	347	2.1	9200	550
RI103	30" Box Outfall	4.66	1600	30	4.46	5400	<10

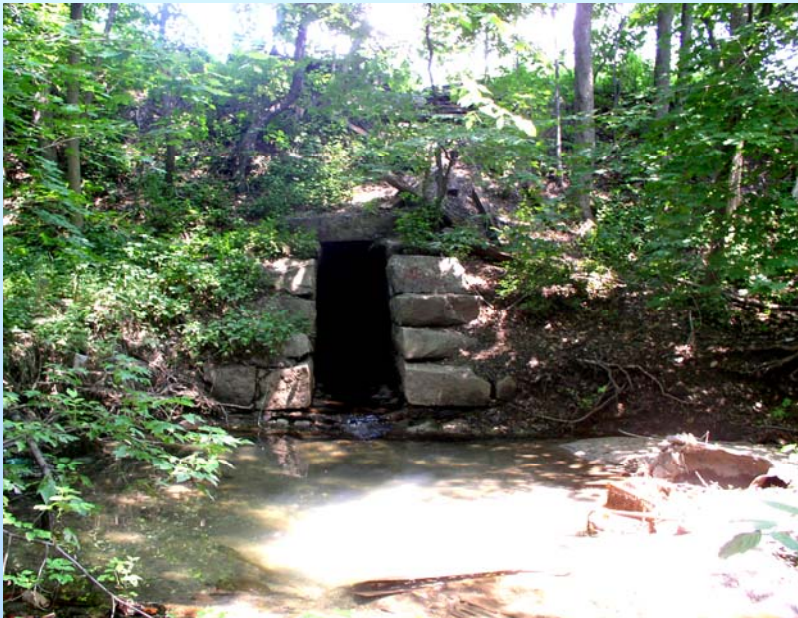
Blackstone River: Ann and Hope Outfall

Fecal Coliform
11/29/2005	16,000
12/22/2005	2400
1/27/2006	>16,000
2/17/2006	5000

Dry Weather Discharge: 7.08 L/Sec
